## P 3.2 HAIL DAMAGE THRESHOLD SIZES FOR COMMON ROOFING MATERIALS

Timothy P. Marshall\*, Richard F. Herzog, Scott J. Morrison, and Steven R. Smith  
Haag Engineering Co. Dallas, Texas

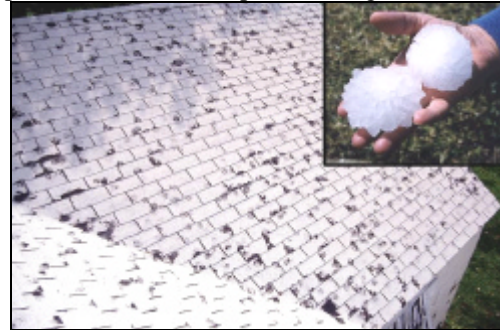
**Figure 1.** Hail damaged asphalt shingle roof from the Fort Worth, Texas hailstorm on May 5, 1995. Large hailstones are shown in the inset photograph.

As expected, there is considerable variation in the size hail necessary to damage a specific roofing product. These variations involve the physical parameters of the hail as well as the roofing products. Hail variations include the stone size, shape, hardness or density, free-fall velocity, and angle of impact. Roof material variations include product type, age, support condition, impact location, and temperature (Fig. 1).

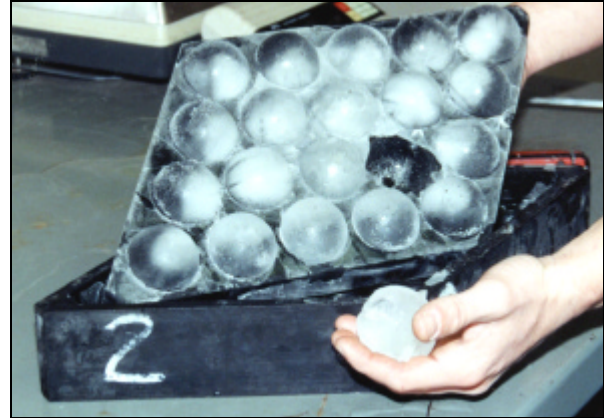
**Figure 2.** Solid ice stones made in rubber molds utilized for impact testing on roofing products.

In the above tests, hard ice stones were launched at target free-fall velocities as shown in Table 1. Generally, the ice stones were made by freezing tap water in molds and were harder and denser than natural hailstones (Fig. 2). Changnon (1996) reported that natural hailstones are slightly less dense than freezer ice since natural hailstones are composed of alternating layers of clear and rime ice as well as air cavities. Thus, the use of freezer ice in impact testing presents a worst case scenario. In addition, many of the impact tests involved striking the roofing samples perpendicularly imparting maximum impact energy to the samples.

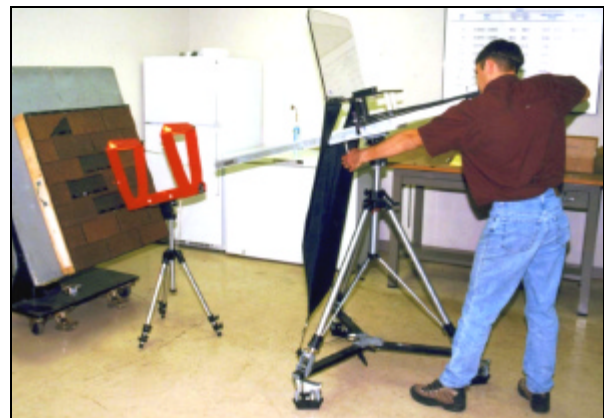
**Figure 3.** Ice ball launching (IBL) device with light sensors (chronograph) developed for impact testing.

Early researchers launched ice stones with pneumatic guns triggered by compressed air. Problems with compressed air-type guns included inconsistency in the ice stone velocity and imprecise targeting. In 1997, Haag Engineers developed a mechanical device dubbed the IBL-7 (Ice Ball Launcher – 7<sup>th</sup> generation) that launched ice stones on a track employing multiple bands of latex tubing (Fig. 3). The tubing ensured consistency in launch velocity and the track guided each ice stone to the desired target point. An ice stone was placed into a plastic holder that kept the stone in place while it accelerated forward. The holder was stopped at the end of the track allowing the ice stone to propel forward. Velocities of the ice stone were obtained by controlling the tension on the latex tubing. The velocities of the ice stones were measured by a chronograph mounted on a tripod at the end of the launcher and connected to a computer. Target launch velocities are shown in Table 1.
