# HAIL DAMAGE TO ROOF SHINGLES

Charles C. Roberts, Jr.

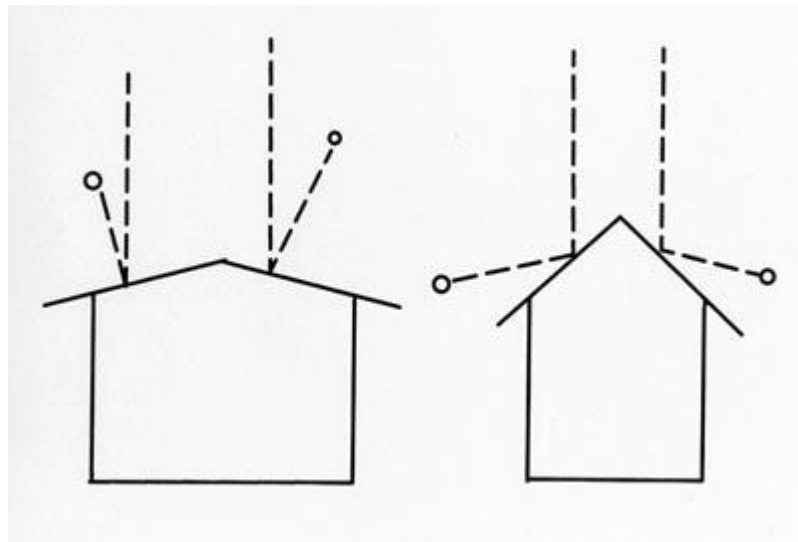
Figure 1a

hail impact on two different roof pitches. The home on the left would sustain more roof damage than that on the right, because of the more direct impact on the left as opposed to the less damaging, glancing, blow to the right. Wind conditions can distort damage to a home as illustrated in Figure 1b. The home on the left has more glancing blows to the roof from the

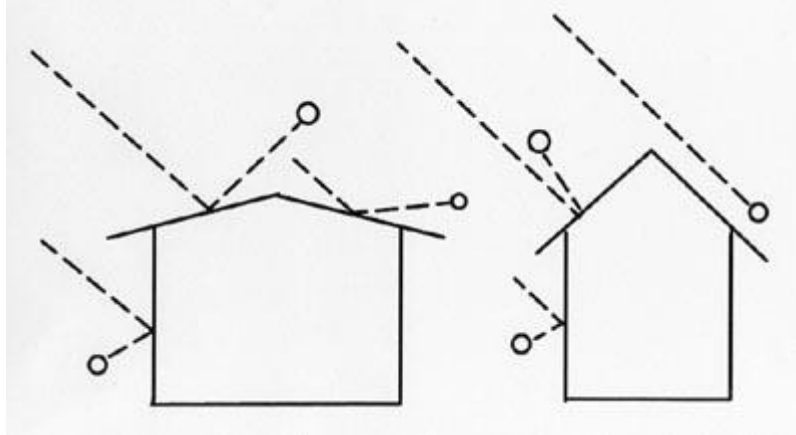
Figure 1b

wind, while the windward wall comes under attack from direct hail impact. The right wall is protected and undamaged from the hail. The home on the right will more likely sustain roof damage on the windward side because of the more direct impact. Assessing hail damage is often accomplished by a roof inspection, which usually occurs several days to several months after the hail event. Determination of whether hail actually fell at a site can be made through statements and weather reports. Inspection of thin, aluminum fixtures helps verify hail impact. Figure 2a shows denting on a roof vent cap indicating that hail had struck the vent at one time.

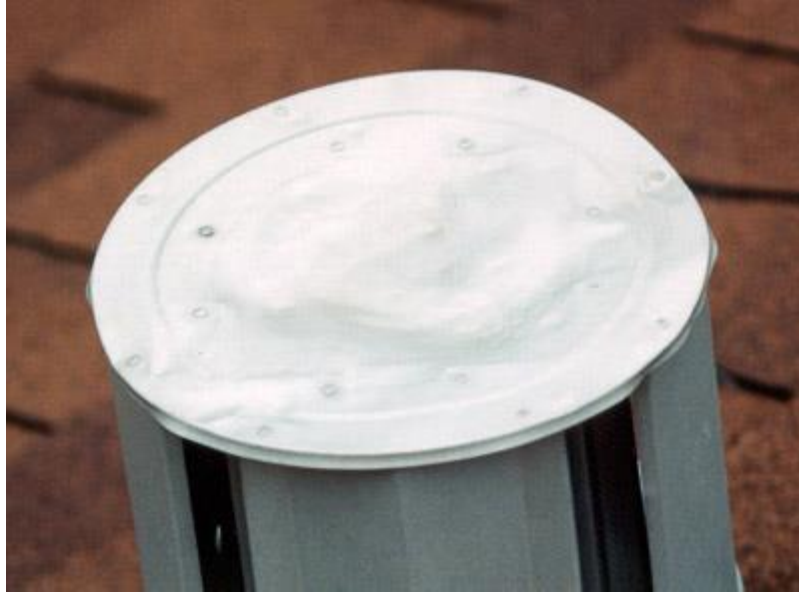
Figure 2b shows denting on a flue vent indicative of hail impact at one time. The denting on these two fixtures does not impede their function.

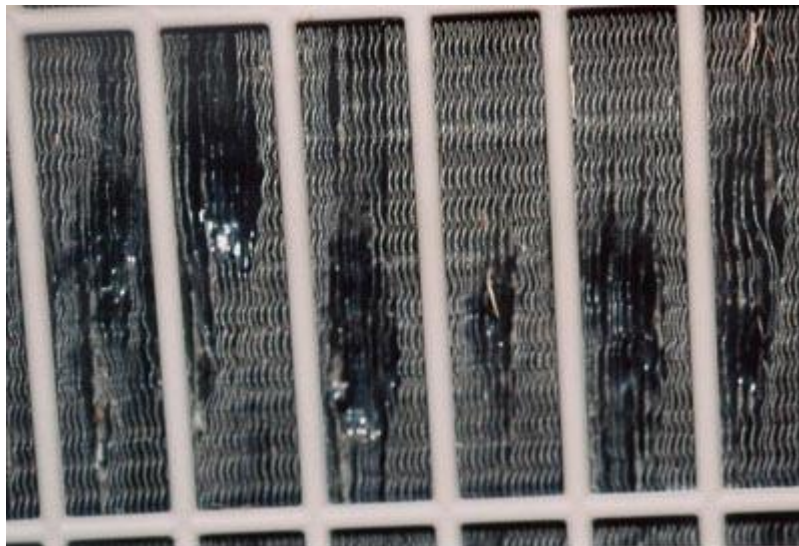
Figure 2c shows deformation to condensing unit fins on an air conditioning system, as a result of a driving hailstorm. This damage does impair operation of the unit, in that air flow through the coils is reduced, causing higher refrigerant temperature, lost performance and lost reliability.

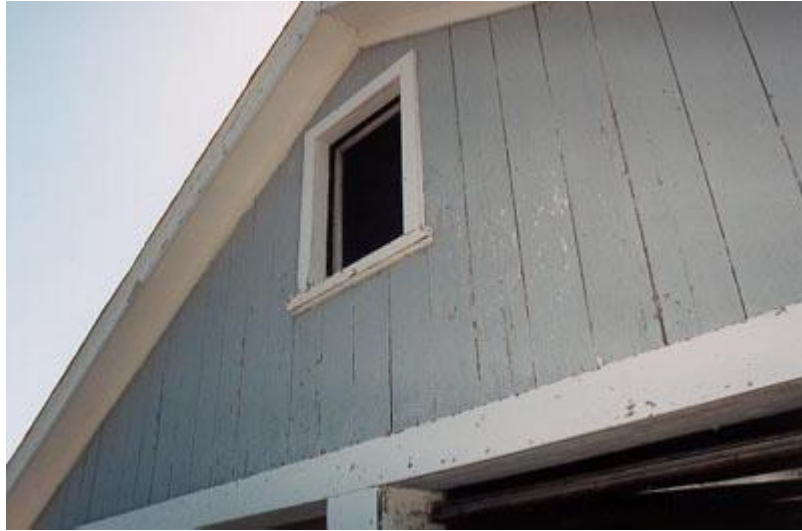
Figure 3 shows shredded and pock-marked paint from a driving hailstorm. The base wood was undamaged but repainting was required.

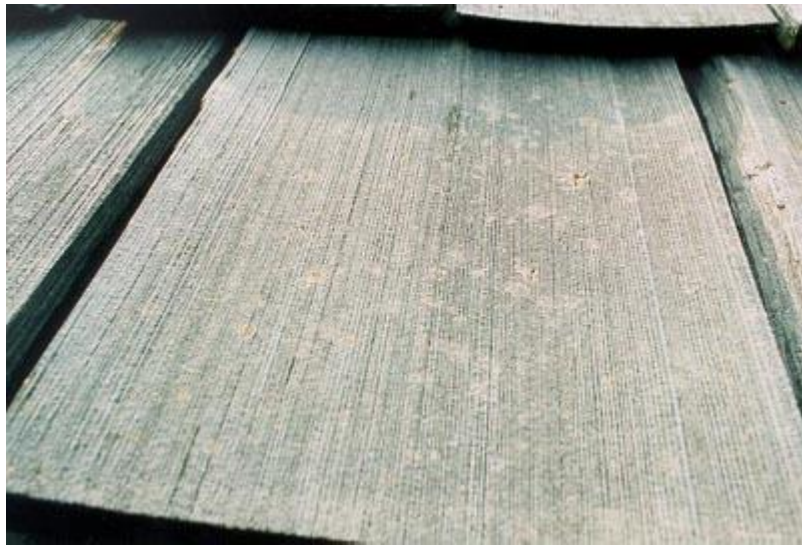
Figure 4 shows mild impact marks on a cedar shingle, consistent with hail impact. These marks will typically dissipate over time with virtually no effect on shingle life. Figure 5 shows more severe shredding from hail impact. If the impact marks are causing severe splits, then shingle life will most likely be adversely affected.

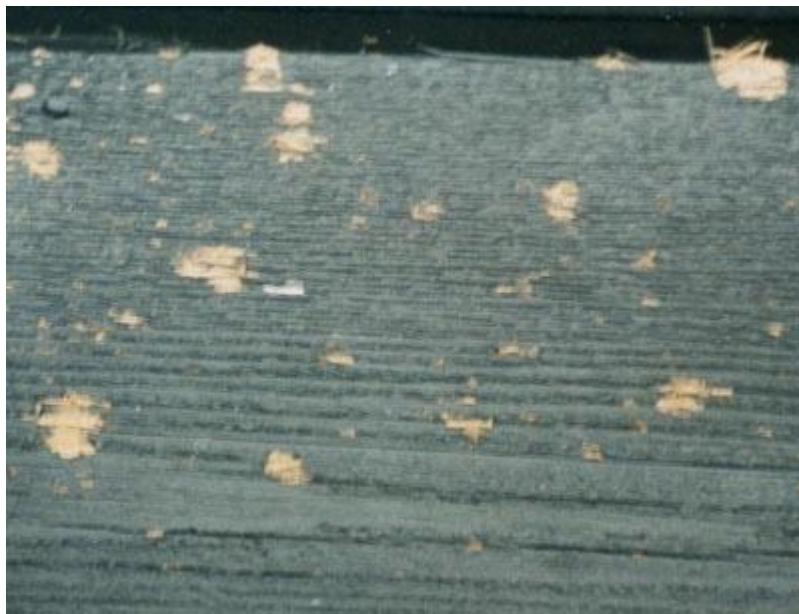
Figure 6 shows impact damage to siding as a result of wind driven hail. Some shredding and minor splitting has occurred but the siding appears structurally sound.

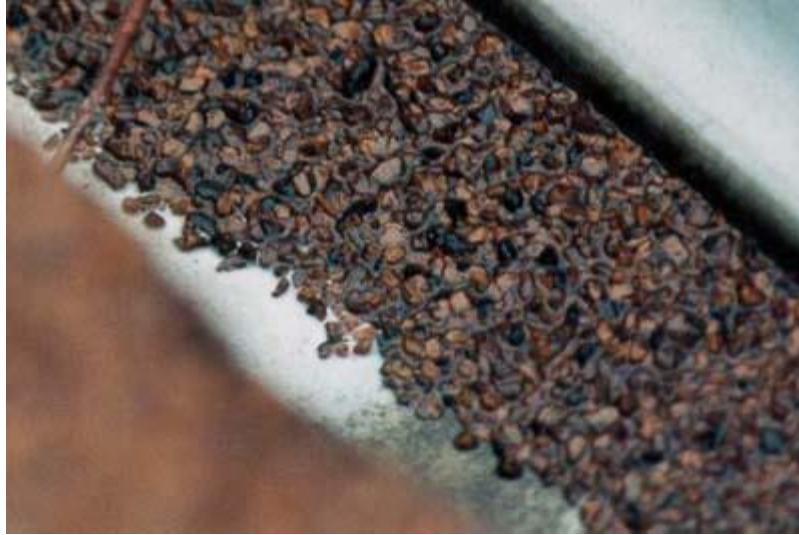
Hail damage to asphalt shingles includes severe granule loss, material removal at the edges of the shingles and penetration. Figure 7 shows grit loss from asphalt after pounding from a hailstorm. New asphalt shingles are more resistant to hail impact than older shingles since the asphalt becomes more brittle with age. Warmer shingles are more compliant and more resistant to fracture from hail when compared with colder shingles. Shingles rely on a structurally sound substrate for hail damage resistance. Flexible roof sheathing allows the shingles to flex during impact causing damage, while more rigid roof sheathing supports the shingle during impact resulting in less shingle damage.
